Chapter 4

Competitiveness

4.1 PERFORMANCE DEMONSTRATION RESULTS

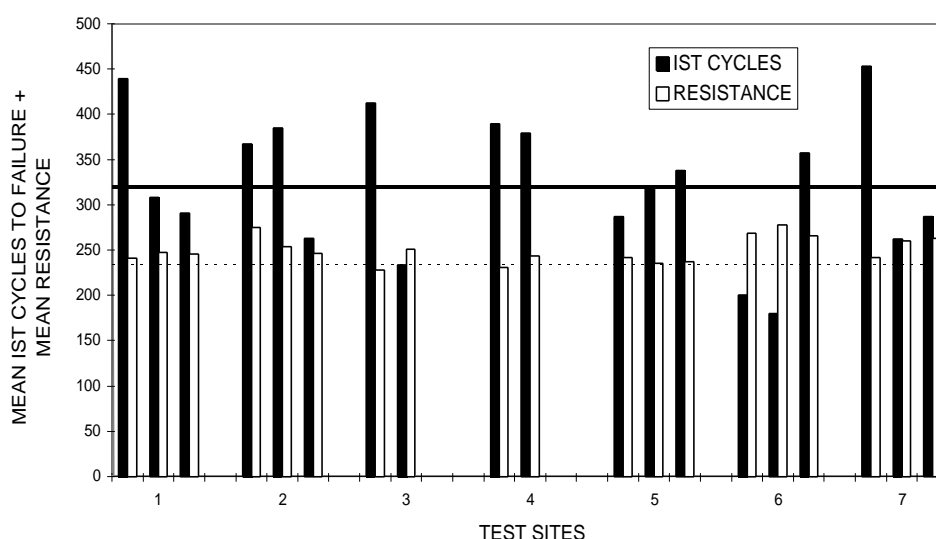
Figure 4.1 Electroless Copper - IST Cycles to Fail vs. Resistance

All electroless copper test sites had at least one panel that met or exceeded the mean performance. As shown in Figure 4.1, for the panels that did not achieve the mean performance, it can be seen that the mean resistance column was above the reference line (thinner copper). The exception was Test Site #6, which exhibited a high degree of post separation (see post separation results section below for an explanation of results). As noted previously, Test Site #6 may not have performed to its true capability on the day of the test. Due to a malfunction in the line, the electroless copper bath was controlled by manual lab analysis instead of by the usual single-channel controller.

Figures 4.1 through 4.6 identify the IST cycles to failure for each panel and test site for each MHC technology. The two reference lines on each graph identify the mean cycles to failure (solid line) for all 300 coupons tested (324 cycles) and the mean resistance (dotted line) for all coupons measured (241 milliohms). When considering the overall performance of each panel, it is useful to compare the mean resistance of the coupons to the dotted reference line. As mentioned before, each test site was instructed to flash plate 0.0001" of electrolytic copper into the holes. If the sites exceeded this thickness, the total copper thickness would be thicker, lowering the resistance and increasing the performance of the panels. Therefore, panels with lower resistance should be expected to perform better, and vice versa. Although each site was requested to plate 0.0001" of electrolytic copper, the actual range was between 0.00005" and 0.0005".

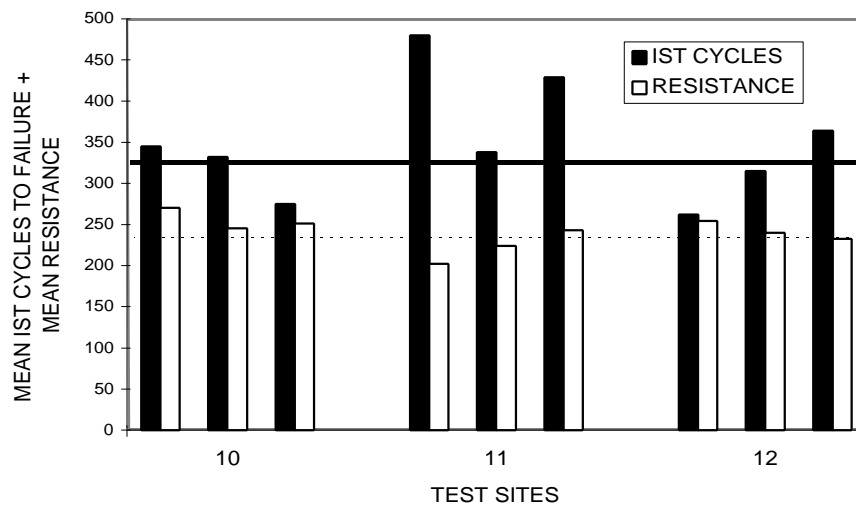
Figure 4.3 Graphite - IST Cycles to Fail vs. Resistance

All three graphite test sites had at least one panel that met or exceeded mean performance, as shown in Figure 4.3.

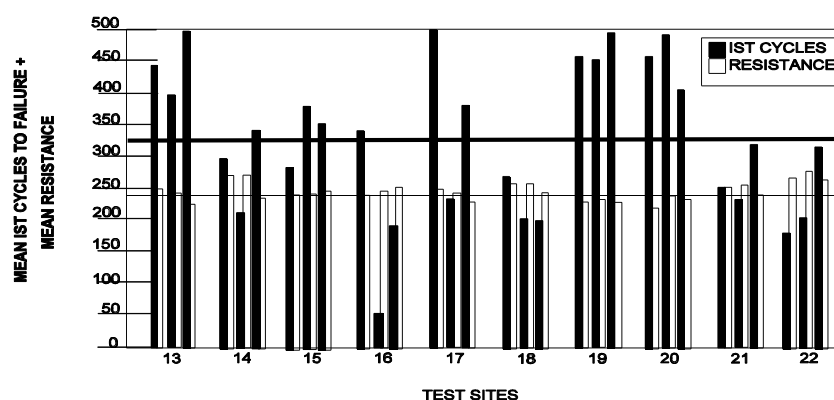
Figure 4.4 Palladium - IST Cycles to Fail vs. Resistance

As shown in Figure 4.4, most palladium test sites had at least one panel that met or exceeded the mean performance. Three test sites did not. Those test sites that did not achieve the mean performance exhibited either high resistance or post separation.

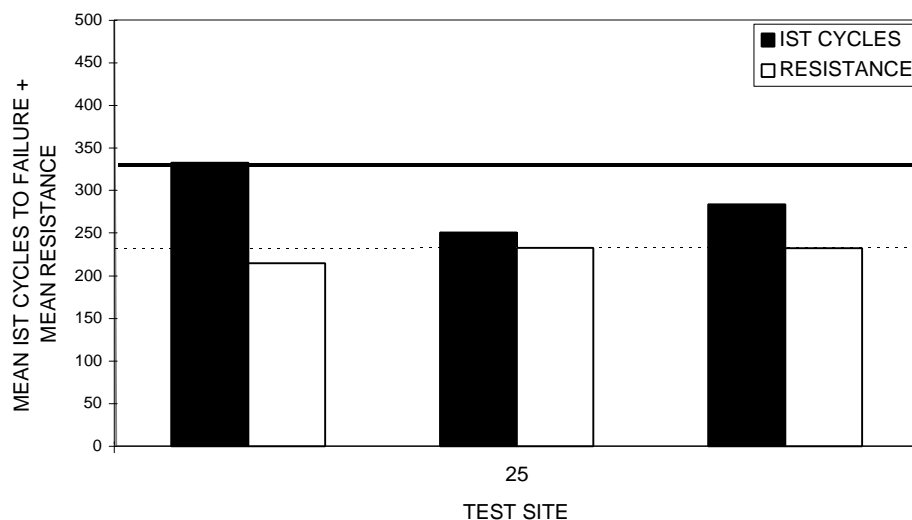
Figure 4.6 Conductive Polymer - IST Cycles to Fail vs. Resistance

As shown in Figure 4.6, the single conductive polymer test site had one panel that met or exceeded the mean performance.

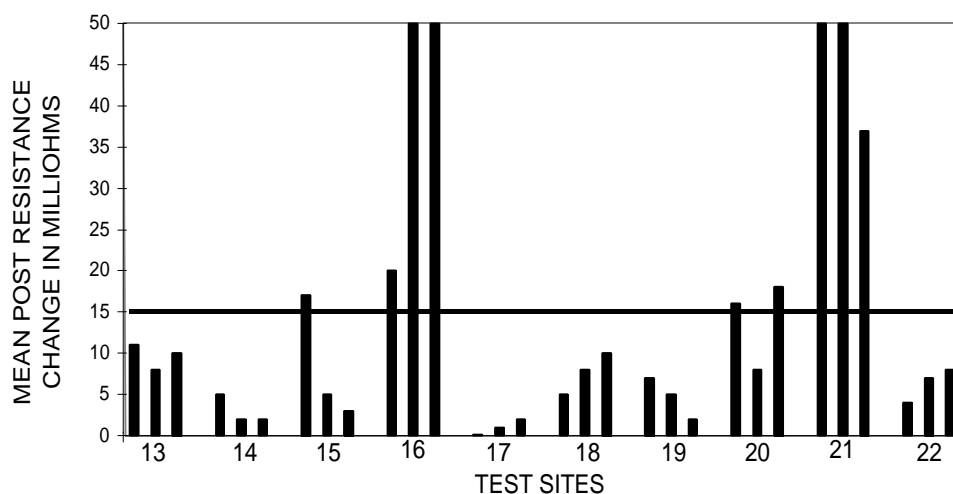
Figure 4.10 Palladium - Post Resistance Degradation

As shown in Figure 4.10, four of the ten palladium test sites had at least one panel that exhibited post separation. Test Site #16 and Test Site #21 clearly exhibited gross post separation.

Figures 4.7 through 4.12 identify the mean (average of four coupons per panel) IST post resistance degradation results. The reference line on each graph identifies the mean resistance degradation measurement for all 300 coupons tested (15 milliohms). If the mean resistance degradation column is above the reference line, the panel had coupons that exhibited post separation. The post resistance change was the value recorded at the point where the PTH (barrel) failed.

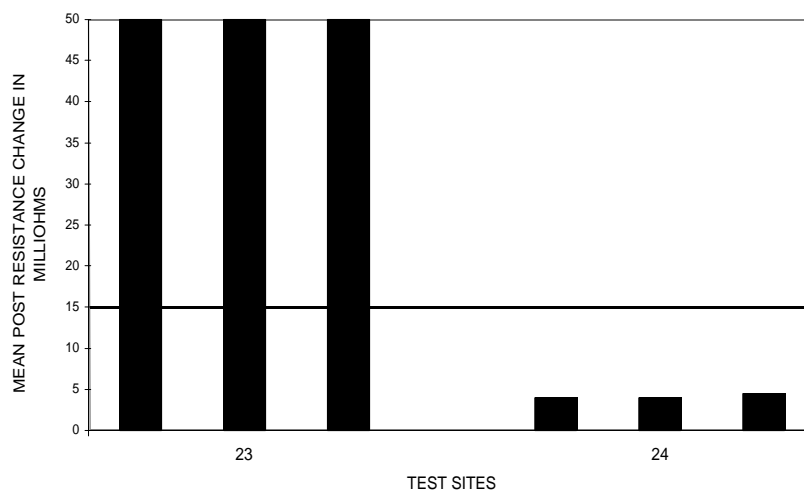
Figure 4.11 Non-Formaldehyde Electroless Copper - Post Resistance Degradation

As shown in Figure 4.11, all three panels for non-formaldehyde electroless copper Test Site #23 clearly exhibited gross post separation.

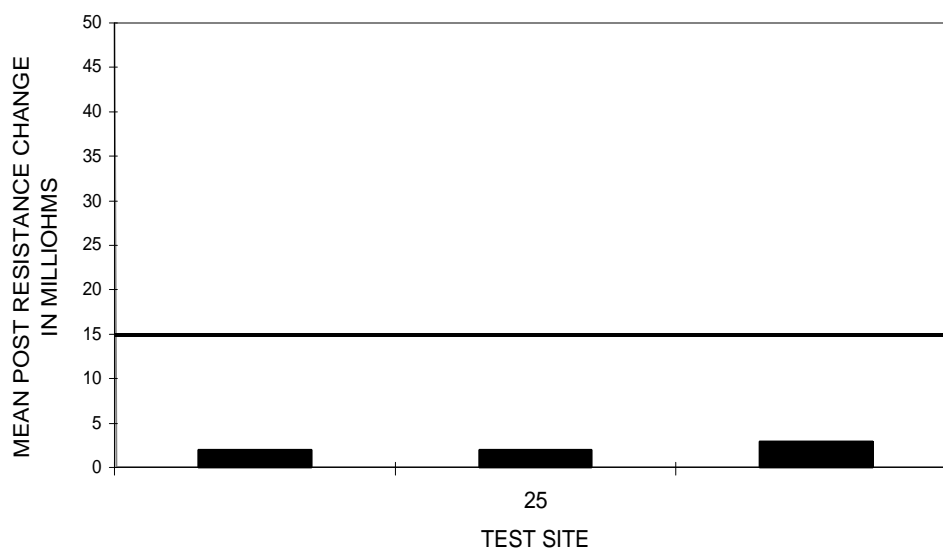
Figure 4.12 Conductive Polymer - Post Resistance Degradation

No post separation was detected on any conductive polymer panels, as shown in Figure 4.12.
